Test report

Test of seat

with regard to Directive / Regulation (EC/EU) / Regulation No. **ECE R17**
taking into consideration amendment No. 08, **Supplement 4**

Approval subject: **Seats, their anchorages and any head restraints**

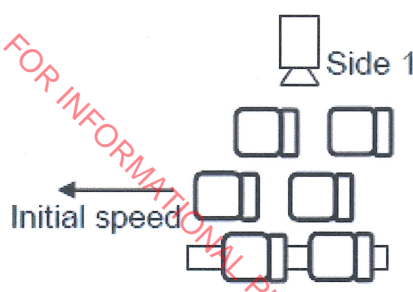
Test A – seats S1TAX02 and S1TAX03 (S1TSF02, S1TSF03)		Test B – seat S1TAX01 (valid for rear impact too)

Torso angle	19°	Torso angle	19°
Longitudinal adjustment	N/A	Longitudinal adjustment	N/A
Vertical adj.	N/A	Vertical adj.	N/A

Test A		Test B	
	Requirement	Measured	Requirement	Measured
Impact speed v_0	50^{+0}_{-2} km/h	Achieved	50^{+0}_{-2} km/h	Achieved
Deceleration	20g for 30ms	Achieved	20g for 30ms	Achieved

5.2.5	There was no failure of the seat frame or seat anchorage, adjustment and displacement systems or their locking devices during the test.
5.2.6.	There was no release of the locking systems during the tests.

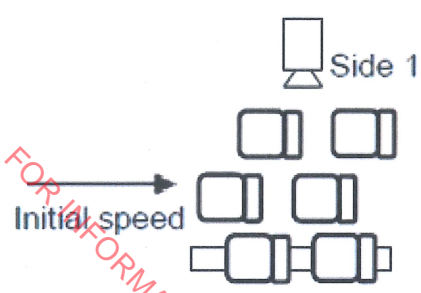
Test C – seats S1TAX02 and S1TAX03 (S1TSF02, S1TSF03)

Torso angle	19°
Longitudinal adjustment	N/A
Vertical adj.	N/A

Requirement	Measured
Impact speed v_0	50^{+0}_{-2} km/h	Achieved
Deceleration	20g for 30ms	Achieved

5.2.5	There was no failure of the seat frame or seat anchorage, adjustment and displacement systems or their locking devices during the test.
5.2.6.	There was no release of the locking systems during the tests.

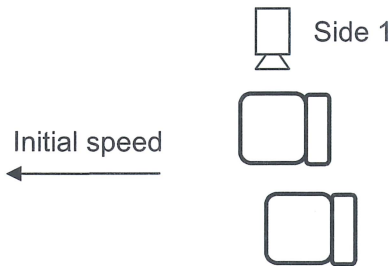
Test D:

- Taxi seat with revolving system mounted on interleg with V-fittings
- Taxi seat with revolving system on slide base

Torso angle	11,5°
Longitudinal adjustment	N/A
Vertical adj.	N/A
Head restraint	Integral

Requirement	Measured
Impact speed v_0	50 ⁺⁰ ₋₂ km/h	48.9 km/h
Deceleration	20g for 30ms	Achieved

5.2.5.	There was no failure of the seat frame or seat anchorage, adjustment and displacement systems or their locking devices during the test.
5.2.6.	There was no release of the locking systems during the tests.

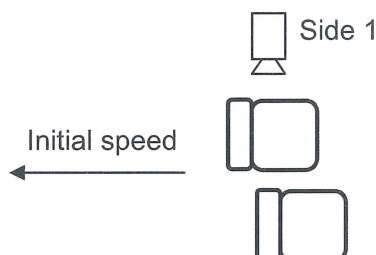
Test E:

- Taxi seat with revolving system mounted on interleg with V-fittings
- Taxi seat with revolving system on slide base

Torso angle	11,5°
Longitudinal adjustment	N/A
Vertical adj.	N/A
Head restraint	Integral

Requirement	Measured
Impact speed v_0	50 ⁺⁰ ₋₂ km/h	48,8 km/h
Deceleration	20g for 30ms	Achieved

5.2.5.	There was no failure of the seat frame or seat anchorage, adjustment and displacement systems or their locking devices during the test.
5.2.6.	There was no release of the locking systems during the tests.

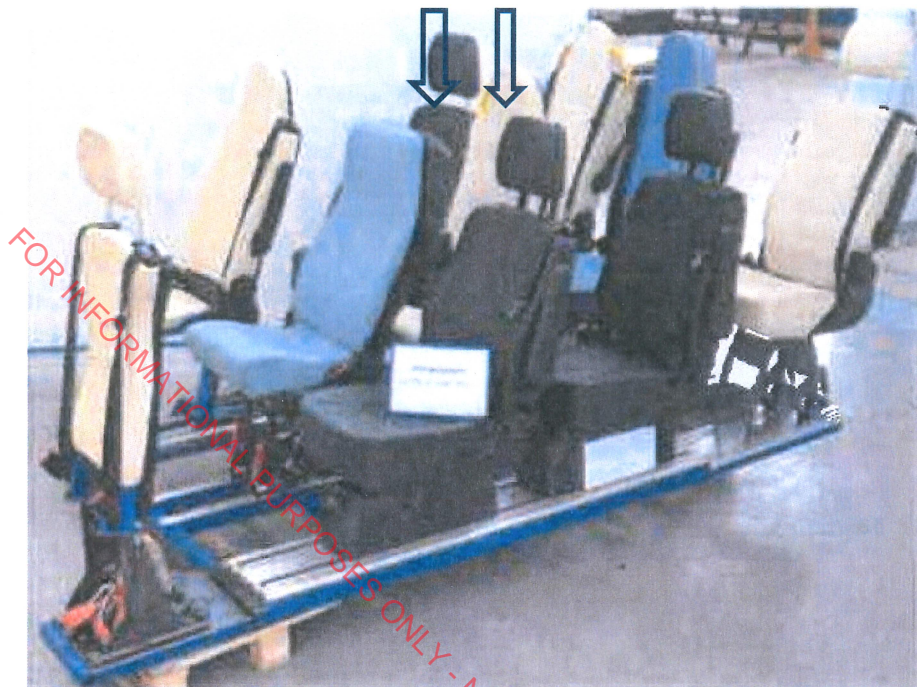
Before test

Forward direction Test D

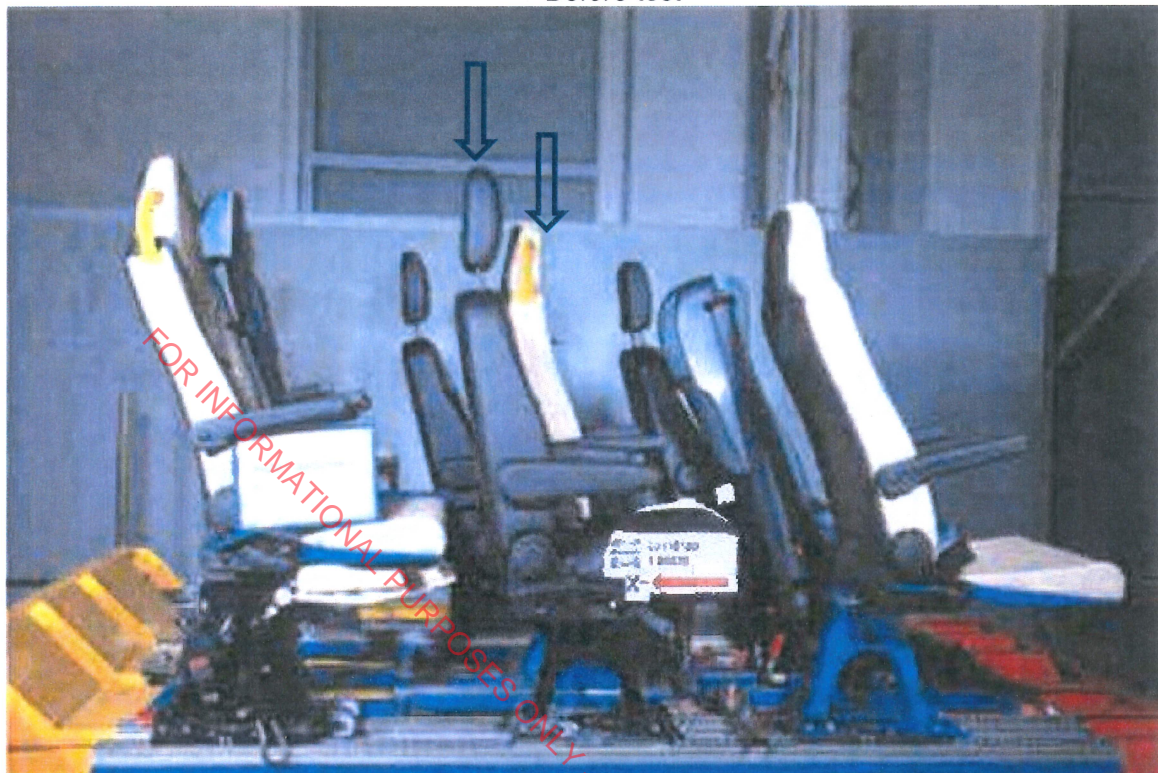
Before test

Rearward direction Test E

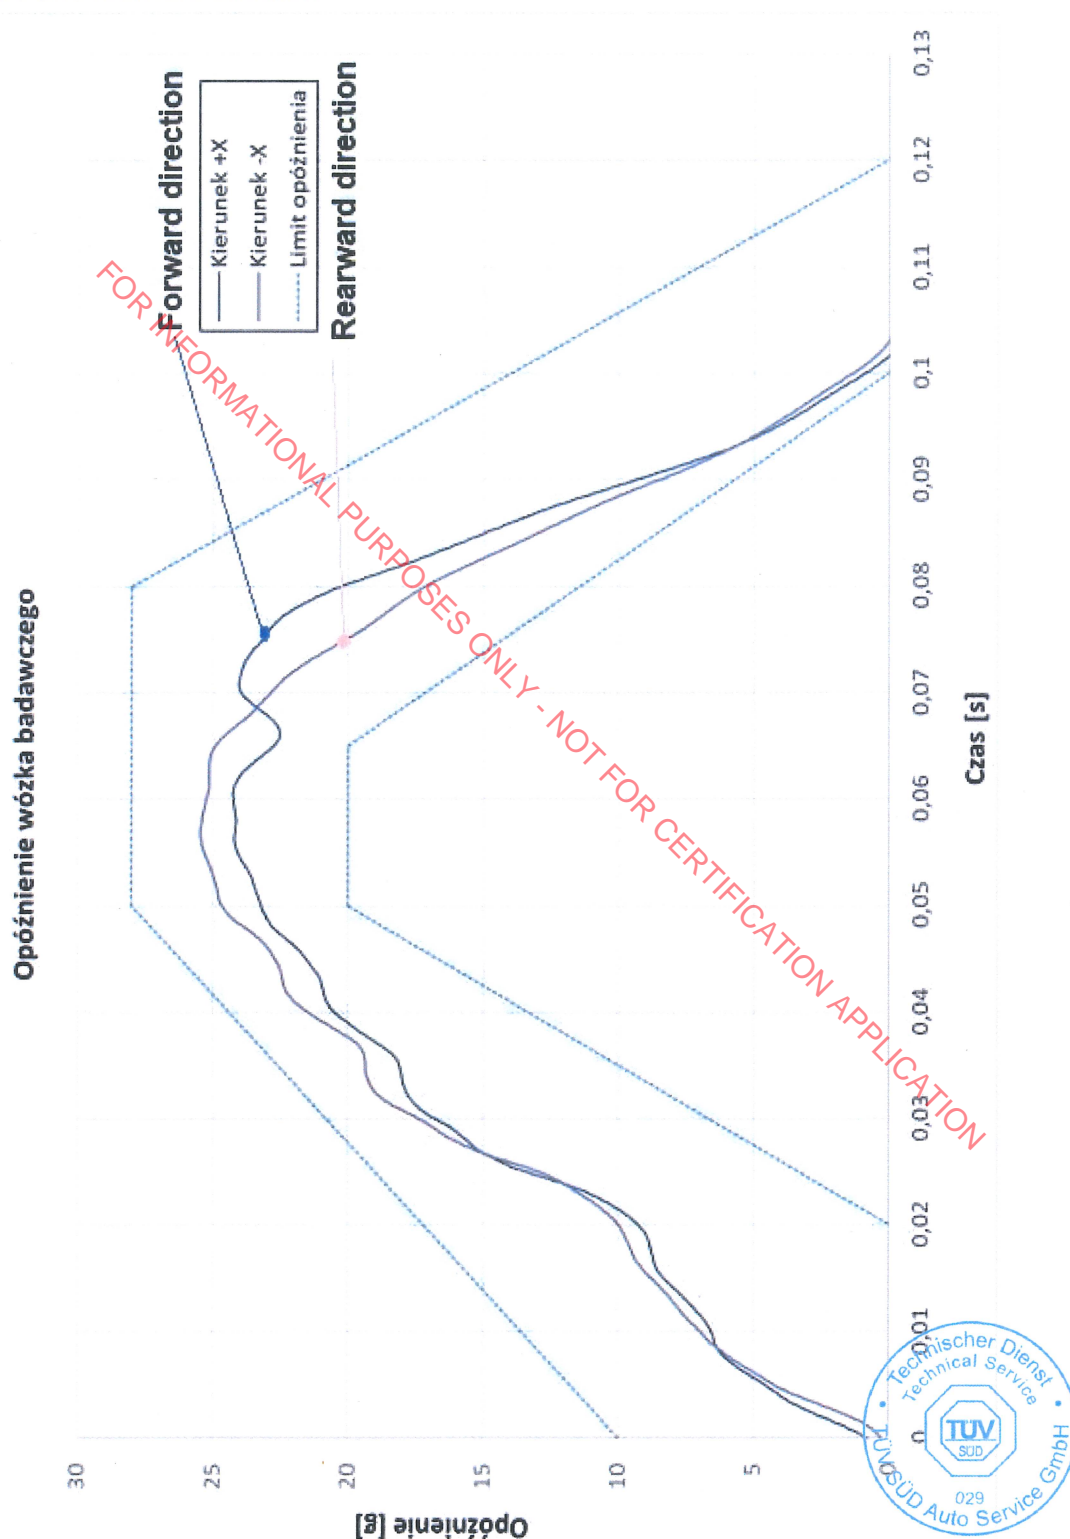
Graphs:

Dynamic tests

Test D, E - taxi seat

Forward and rearward direction
